**National Highway
Traffic Safety
Administration**

Case Vehicle (A): 1998 Ford
Type: F-150 XLT Super cab 4 x 2, 3-door pickup
Driver: 43-year-old female
CDC: 01-FDEW-3

Veh. (B): 1989 Ford
Type: Festiva LX, 2-door hatchback
Driver: 17-year-old female
CDC: 12-FDEW-3

This is a fatal crash; the driver of vehicle (B) was pronounced dead at the scene.

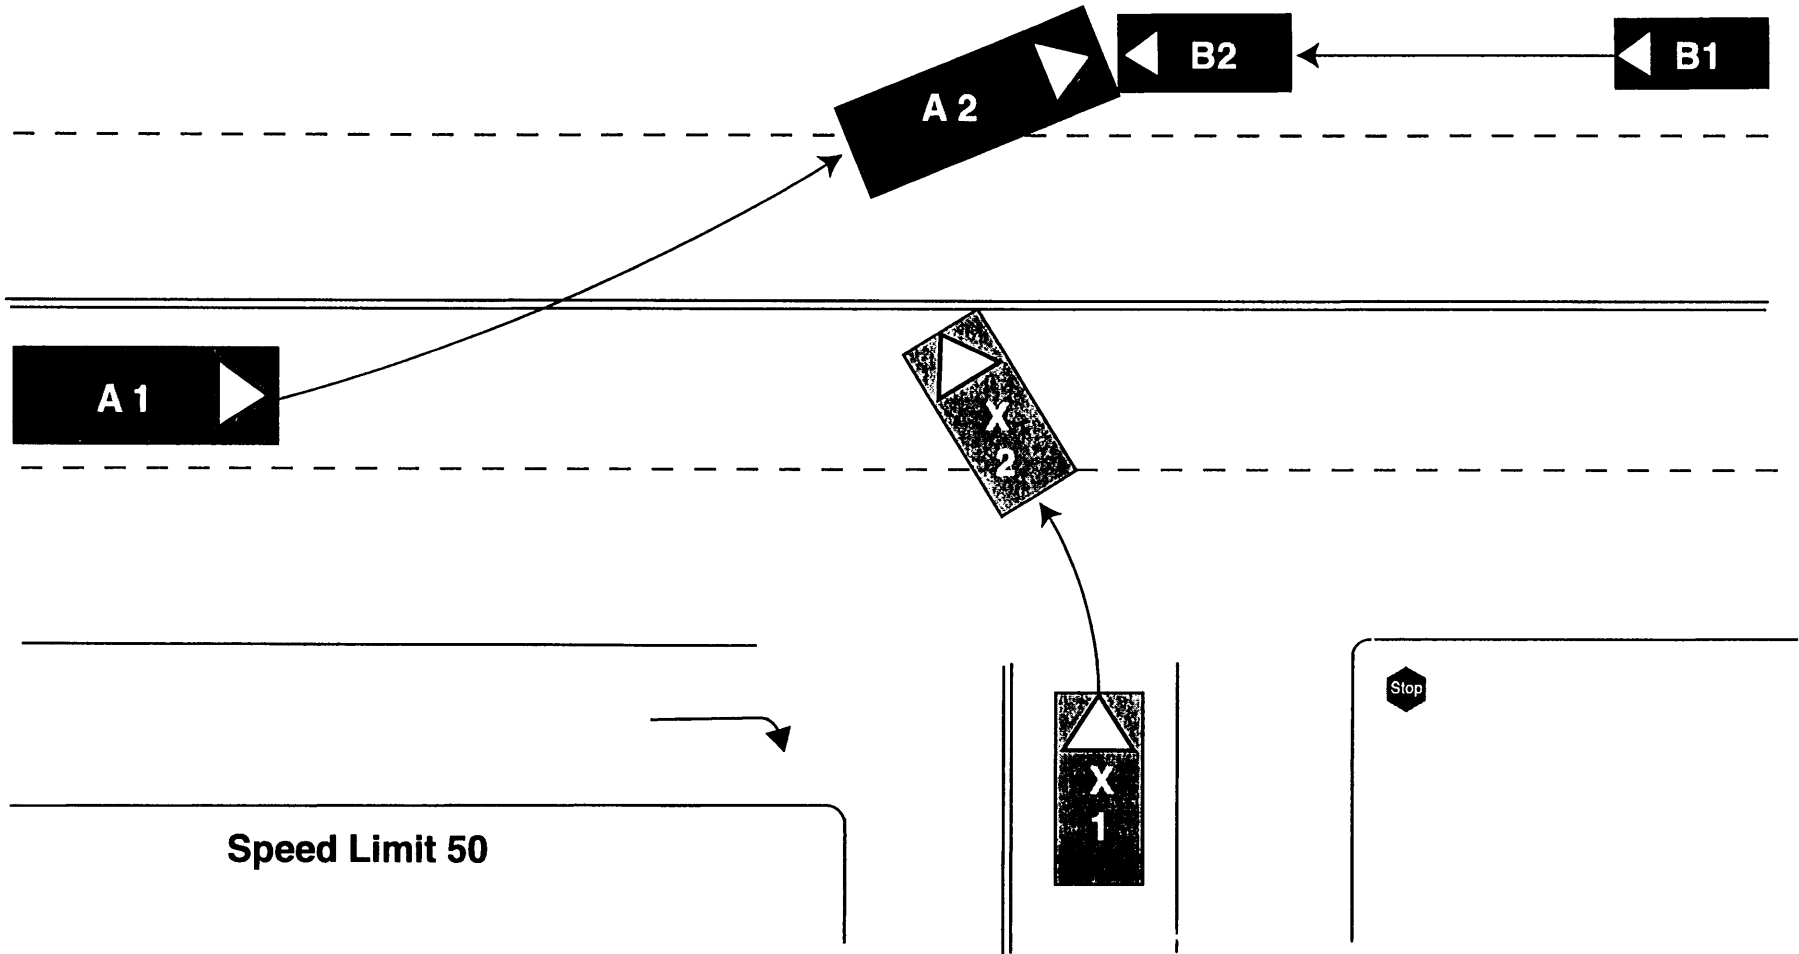
NORTH

(Slide 1) It was daylight, the skies were clear, and (slide 2) the four-lane, asphalt surface was dry and free of defects. Case vehicle (A) was traveling north at a unknown speed in the left northbound lane. Vehicle (B) was traveling south in the right southbound lane. Vehicle (X) was stopped facing west on a three-lane asphalt road that intersects with the north-south 4-lane road. As case vehicle (A) and vehicle (B) approached the intersection of the two roads, vehicle (X) pulled out into the northbound lanes and stopped in the path of case vehicle (A). The driver of case vehicle (A) steered to the left into the southbound lane to avoid striking vehicle (X). The driver of vehicle (B) was unable to take any evasive maneuvers, and the front of case vehicle (A) struck the front of vehicle (B), resulting in significant underride to the front of case vehicle (A) and override to the front of vehicle (B). The driver of vehicle (B) died at the scene. The right-front passenger of vehicle (B) was flown to a local area hospital and was treated for life-threatening injuries. The driver, right-front, center-rear, and right-rear passengers of case vehicle (A) did not report any injuries.

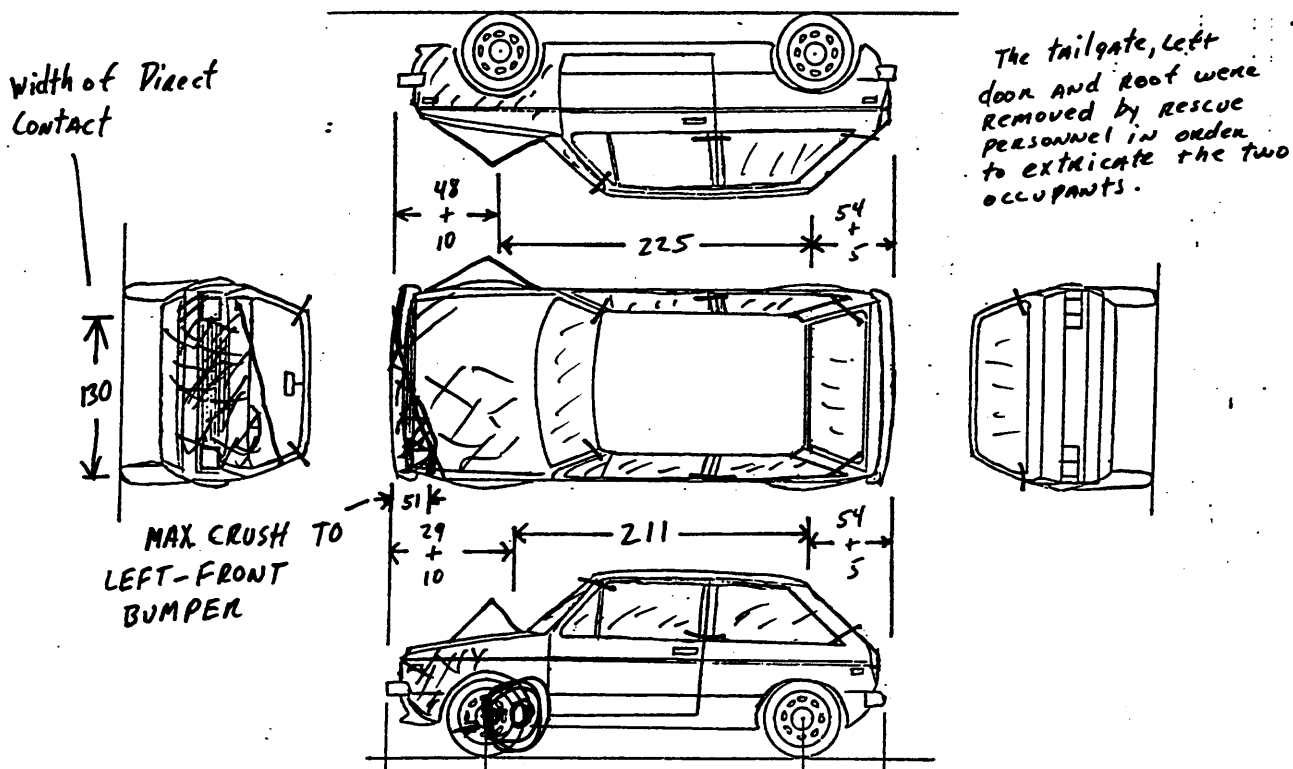
VEHICLE DAMAGE

(Slide 5) Damage to vehicle (B) was severe. (Slide 6) The direct damage to vehicle (B) began at the left-front bumper corner and extended 84 cm to the right. (Slide 7) The maximum crush was 51 cm to the left-front bumper. The left wheelbase was reduced 18 cm and the right wheelbase was reduced 5 cm. (Slide 8) Rescue personnel cut the upper A- and B-pillars to remove the roof, the hatchback, and (slide 9) the left door in order to extricate the occupants.

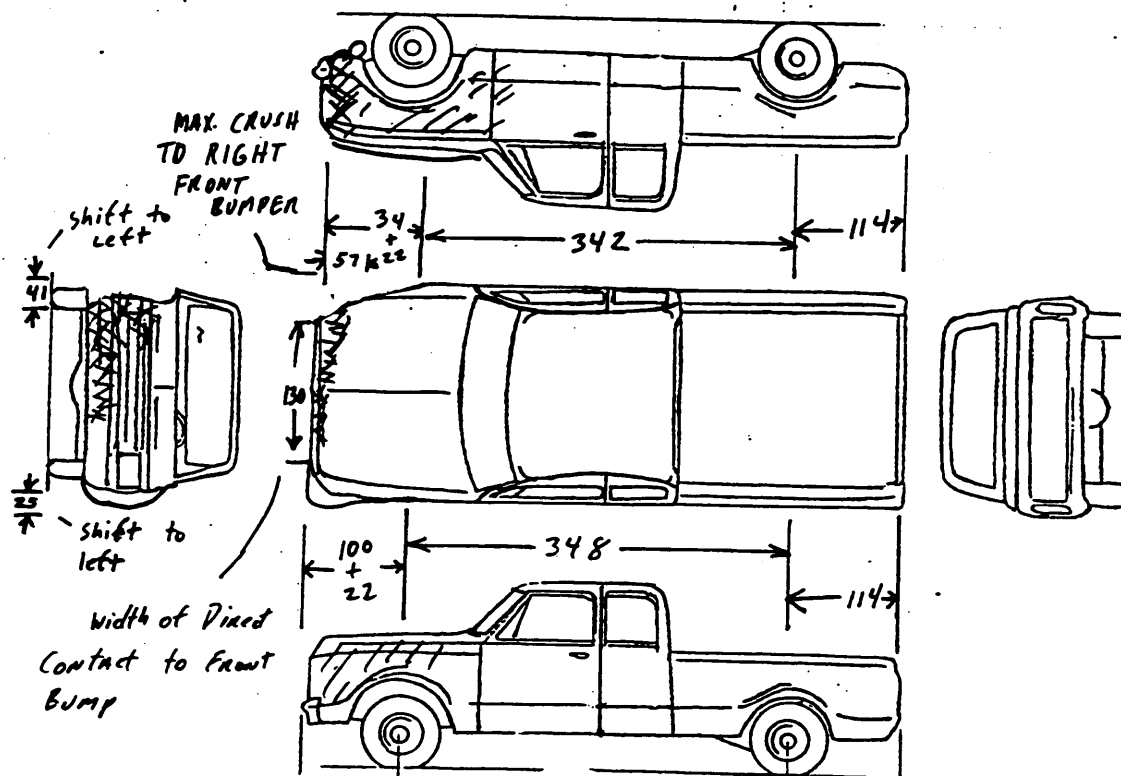
VEHICLE DAMAGE

(Slide 3) Direct damage to case vehicle (A) began at the right-front bumper corner and extended 130 cm to the left across the front, resulting in 70-percent vehicle overlap. (Slide 4) The maximum crush was 57 cm to the right-front bumper.

Direct Damage Length (DDL) 130 cmFront-End Overlap (Percent) = $\frac{DDL}{UEW}$ 72%Vehicle Overlap (Percent) = $\frac{DDL + 1/2 (OAW - UEW)}{OAW}$ 70%

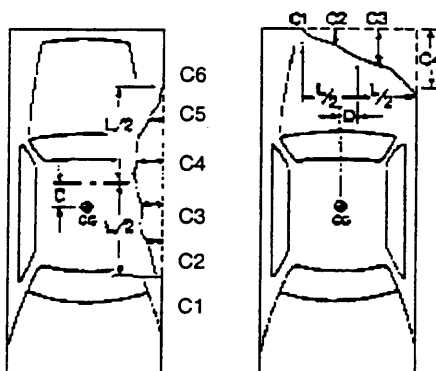
Specific Impact No.	Location of Direct Damage	Location of Field L
1	50 cm Undamaged	Ft. bumper BC to BC

DL 130

UDL 50

Specific Impact Number	Plane of Impact C-Measur.	Direct Damage		Field L	C ₁	C ₂	C ₃	C ₄	C ₅	C ₆	±D
		Length (DDL)	Max Crush								
1	1	130	64	155	27	20	35	52	64	77	+34
			-7		-22	-7	-1	-1	-7	-22	
1	1	130	057	155	005	013	034	051	057	055	+034
13	14	15 16 17	18 19 20	21 22 23	24 25 26	27 28 29	30 31 32	33 34 35	36 37 38	39 40 41	42 43 44 45
2

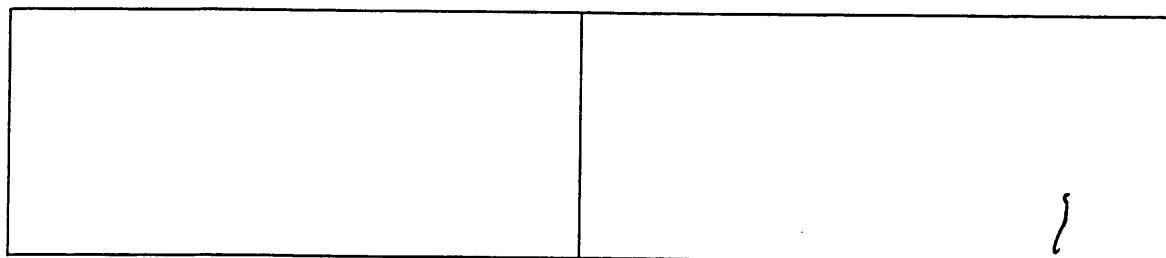
LOCATE AREA OF WINDSHIELD INTEREST OR DAMAGE WITH DIMENSIONS (VERTICAL
 & HORIZONTAL) ON THIS DIAGRAM OF THE WINDSHIELD AS VIEWED FROM INSIDE.

CRACKED

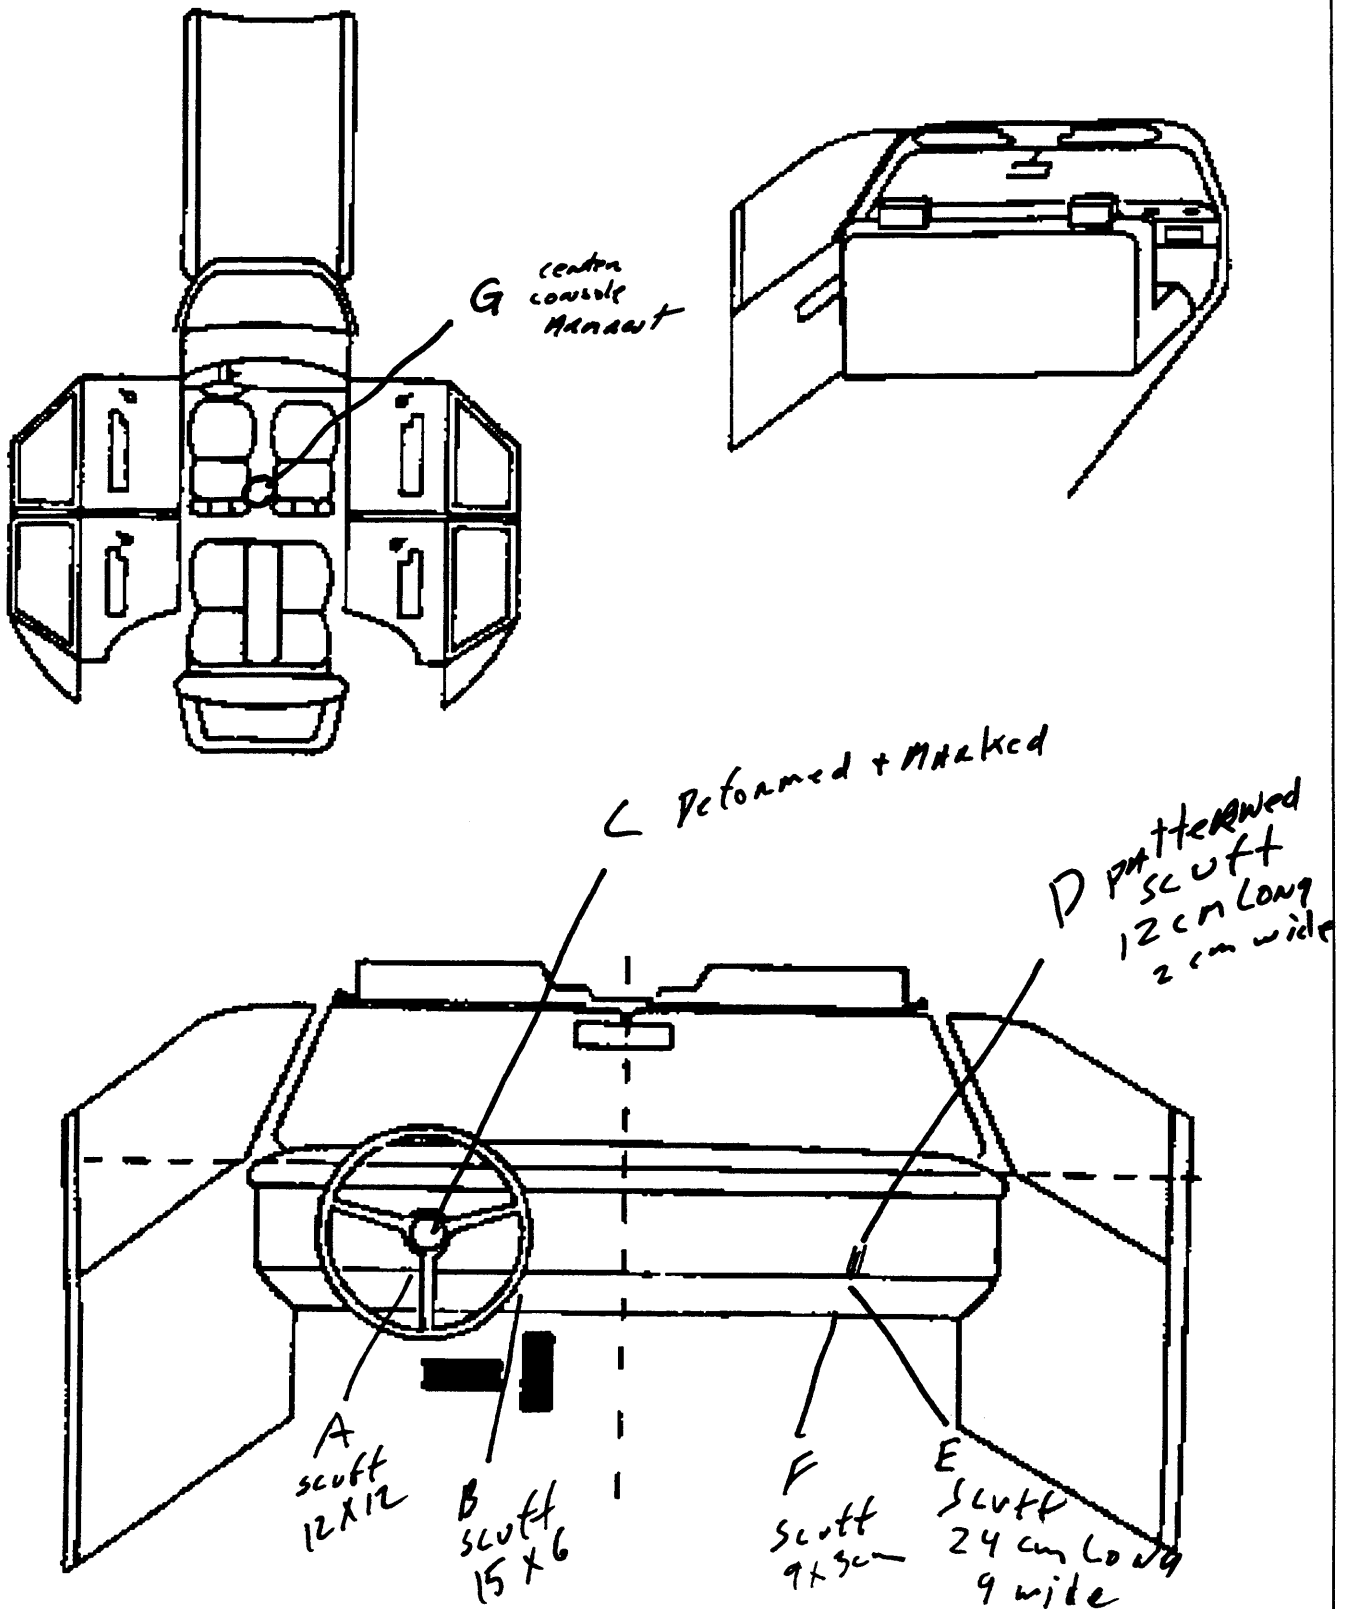
VEHICLE OCCUPANT CONTACT DIAGRAM

Contact	Interior Component Contacted	Occupant No. if Known	Body Region if Known	Supporting Physical Evidence	Confidence Level of Contact Point
A	Knee Bolster	DR	Lt. Knee/leg	Scuff	1
B	"	DR	Rt. Knee/leg	Scuff	1
C	SW Hub	DR	Handy forearm	Deformed + marked	2
D	Glove box	RF	Rt. leg	Scuff	1
E	"	"	"	Scuff	1
F	Duct	"	"	"	1
G	center console	RC	Arms/face	Scuff	2
H					
I					
J

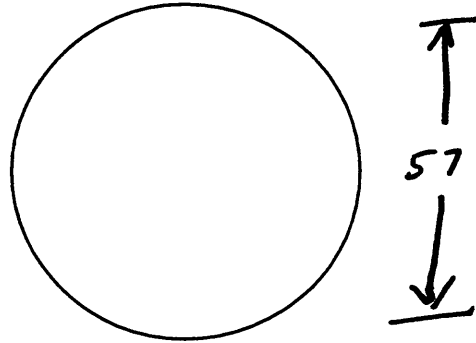
NOTE AND DESCRIBE ANY AIRBAG CONTACT OR
DAMAGE ON DIAGRAM BELOW:

This vehicle was equipped with steering-wheel and passenger frontal-impact airbags, and (slides 27 and 28) both deployed. (Slide 29) The right-rear portion of the steering-wheel airbag fabric was burned and melted. (Slides 30, 31, 32 and 33) The upper flap of the steering-wheel airbag module cover was deformed, (slides 34 and 35) and there was a scuff mark on the lower flap. (Slides 36 and 37) There was no damage to the passenger airbag module cover, (slide 38) but there was a scuff mark on the upper left edge. (Slide 39) There was no damage to the steering-wheel rim or (slide 40) spokes. (Slide 41) The plastic knee bolster cover, (slide 42) upper vent outlets, (slide 43) right-front door panel, and (slide 44) front-seat center armrest were damaged.

2 VENTS @
11 + 1 o'clock

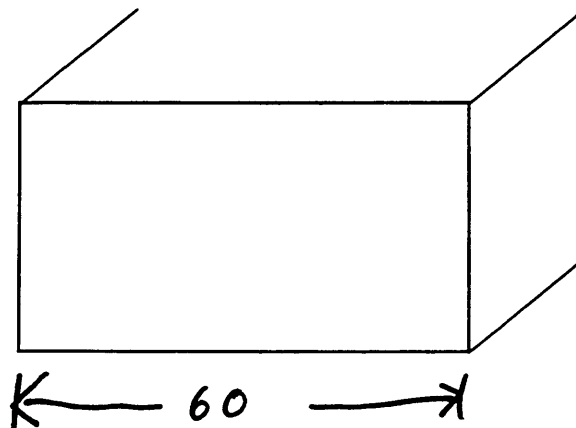
NOTE AND DESCRIBE ANY AIRBAG CONTACT OR
DAMAGE ON DIAGRAM BELOW:

NO VENTS
17 TALL
39 WIDE

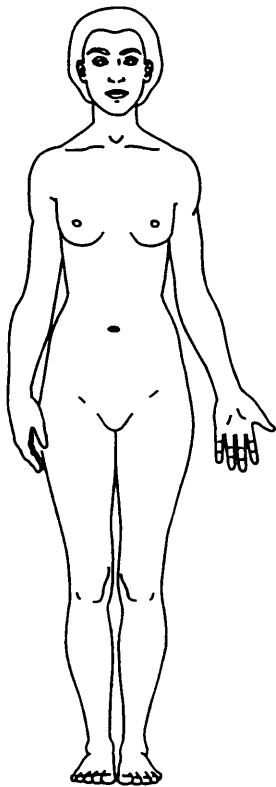
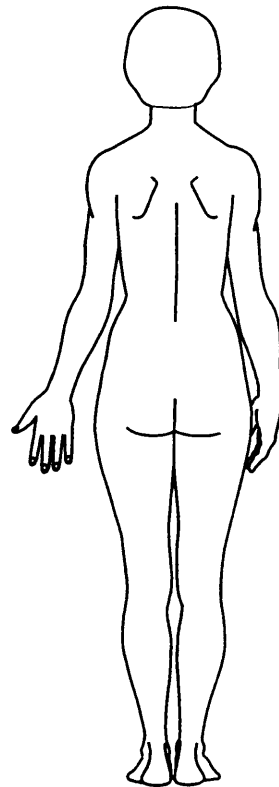
INDICATE LOCATION OF INJURIES.

No reported injury

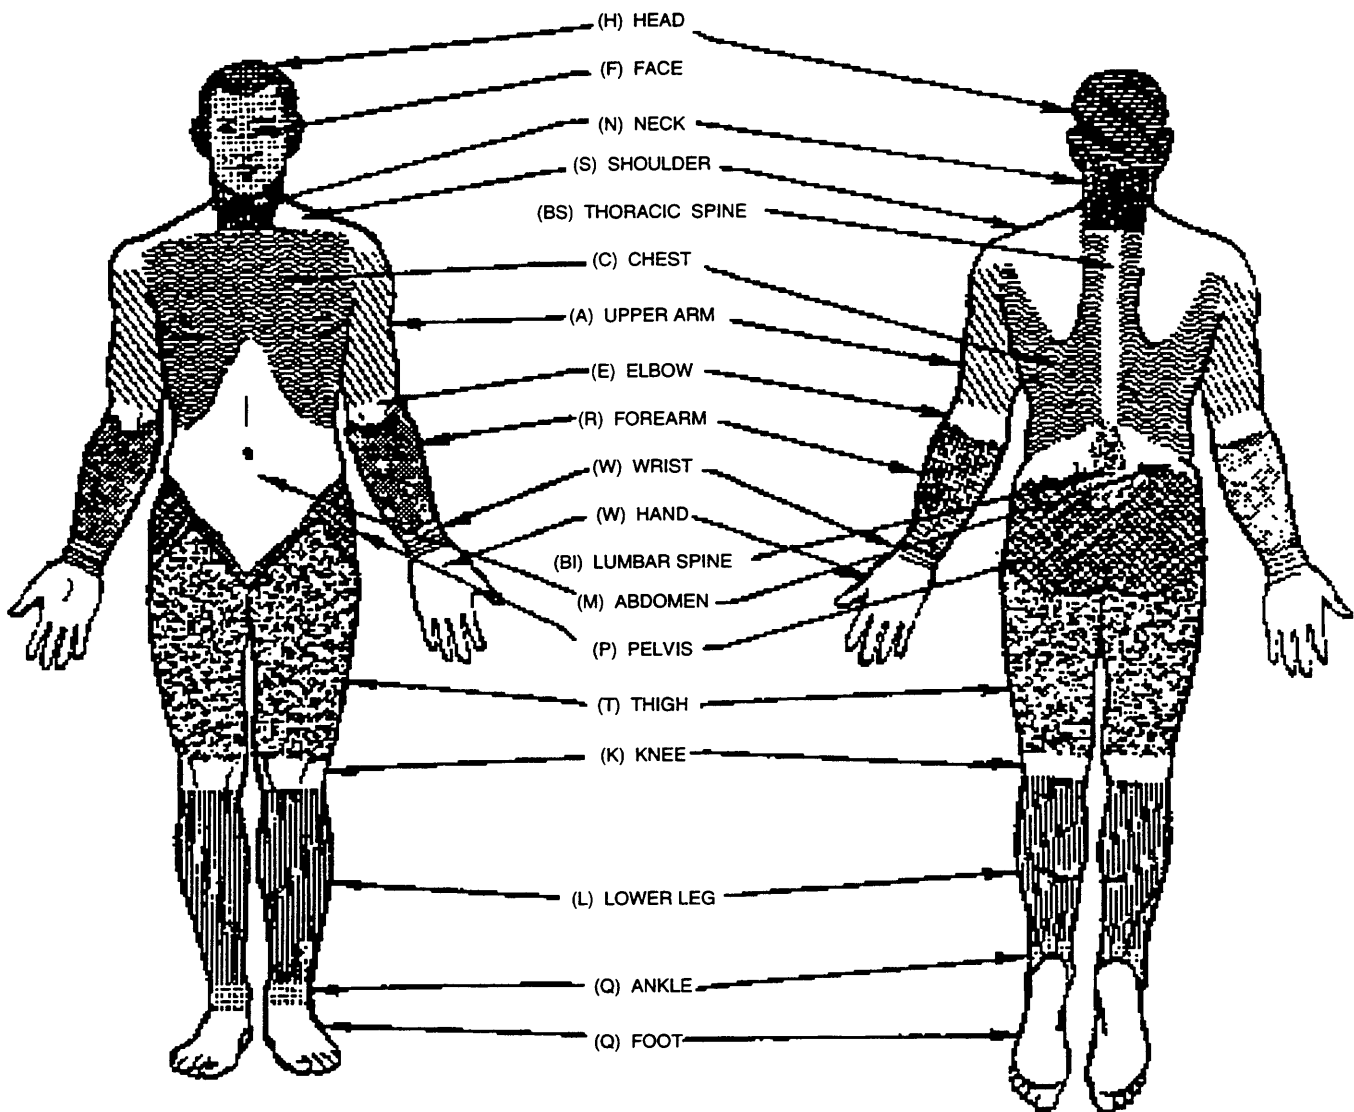
THE FIGURE BELOW
IS AN EXPLANATION OF THE BODY REGION CODES
LISTED ON PAGE IC - 4.

CODES FOR OCCUPANT INJURY CLASSIFICATION (OIC)
